Cermak Rd and Mannheim Rd <Southbound>

Westchester, IL RLR 3 Year Follow-Up Evaluation Report

Reference No: 016-59690

May 2022

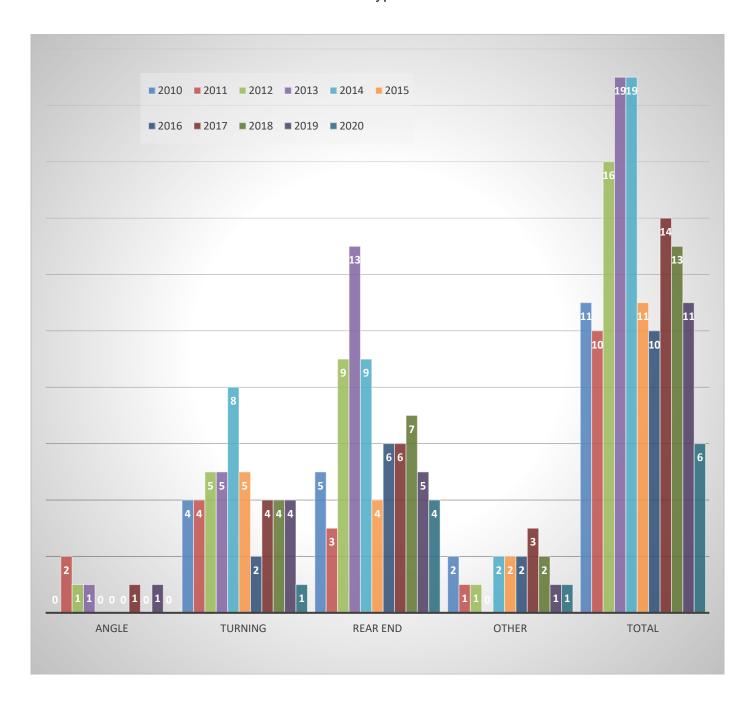
The Chart below shows the trend of each crash type from 2010-2020.

From 2010-2012, prior to RLR camera installation, there were 37 total crashes; this averages out to 12.33 crashes a year.

From 2014-2020, post RLR camera installation, there were 84 total crashes; this averages out to 12 crashes per year - a 2.7% reduction of overall crashes in direct comparison with the time period aforementioned.

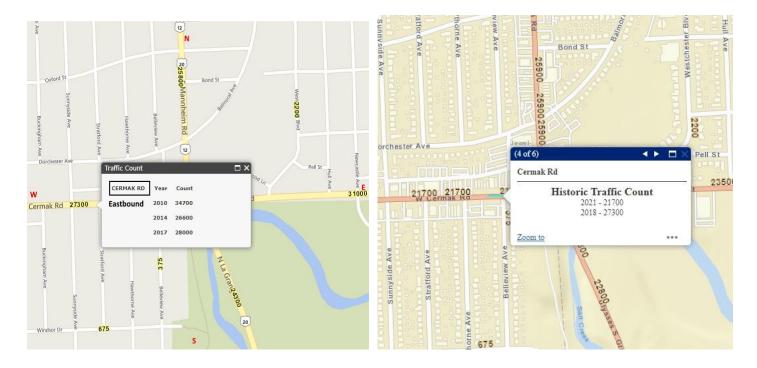
Eastbound ADTC

The traffic numbers below were obtained from the IDOT website during the preparation of past reports and now per the RLR Guideline document published by the IDOT. Only ADTC values were available, peak numbers were not provided.
