Roosevelt Rd and Mannheim Rd <Westbound and Northbound>

Westchester, IL RLR 3 Year Follow-Up Evaluation Report

Reference No: 016-59804 May 2022

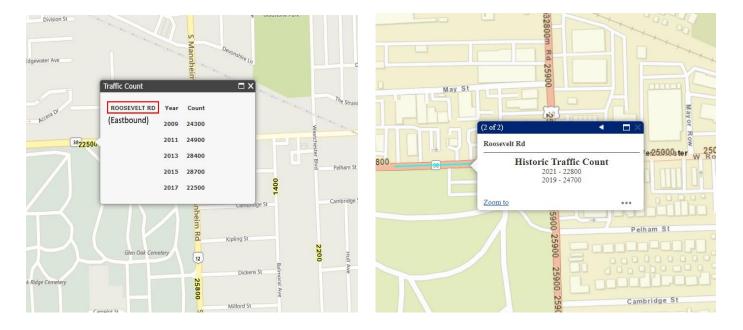
Eastbound ADTC

The traffic numbers below were obtained from the IDOT website during the preparation of past reports and now per the RLR Guideline document published by the IDOT. Only ADTC values were available, peak numbers were not provided.
